PVP2009-77522

## ANALYSIS OF SURFACE STRAINS AND LEAKAGE BEHAVIOR IN COMPOSITE PIPES AND VESSELS USING DIGITAL IMAGE CORRELATION TECHNIQUE

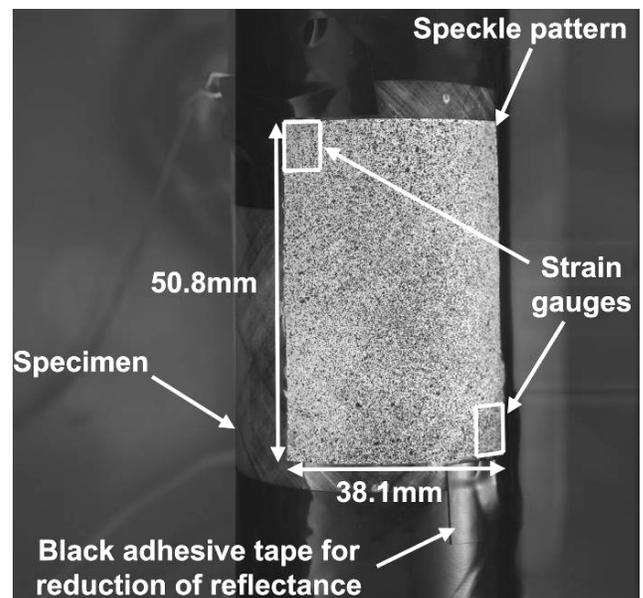
Figure 1: Specimen equipped with strain gages and speckle pattern.

speckle pattern strain gages were attached on the specimen surface in opposite corners of the rectangular pattern zone. To suppress light reflections and glare, black adhesive tape was also attached to the specimen surface as needed. A specimen close-up with speckle pattern and strain gages is shown in Fig.1.

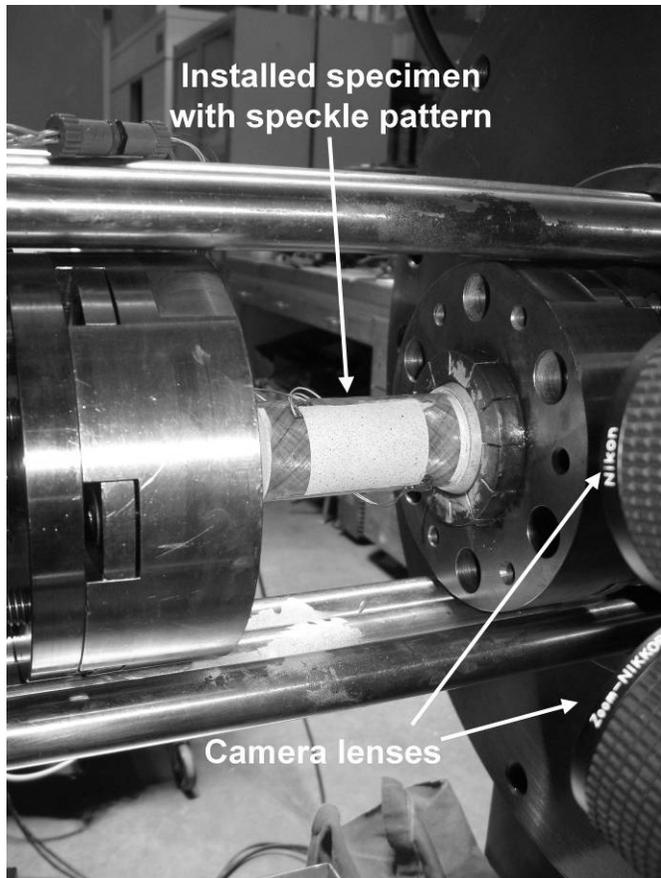
Figure 2: Specimen installed into testing machine.

A custom-made testing machine was used to apply axial force and internal pressure to the specimens. To properly mount specimens into the testing machine's gripping system and load train for the application of axial force (shown in Fig.2), specimens were equipped with metallic end tabs. Hydraulic oil from a pressure intensifier was supplied to the specimen. The testing machine used an analog controller system in combination with a personal computer running National Instruments' LabView software. Besides controlling internal pressure and axial force this system also performed data acquisition tasks. The following data were recorded: test time, internal pressure, axial load, circumferential gage strain, and axial gage strain.

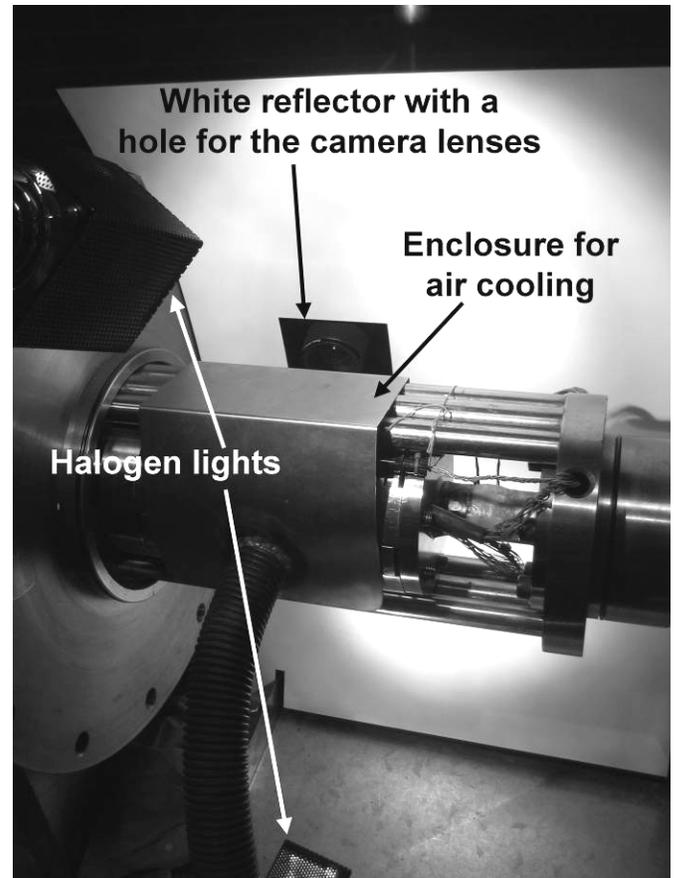
Figure 3: Final setup for DIC image acquisition.

Bright illumination of the specimen surface was required. To achieve even illumination without glare, a curved white reflector was used that was illuminated by two 250 W halogen lights, see Fig.3. To avoid thermal effects during testing, an ambient airstream was directed through a special enclosure onto the backside of the specimen. Once a steady state was reached the specimen temperature was 29°C, which was considered to be room temperature conditions.

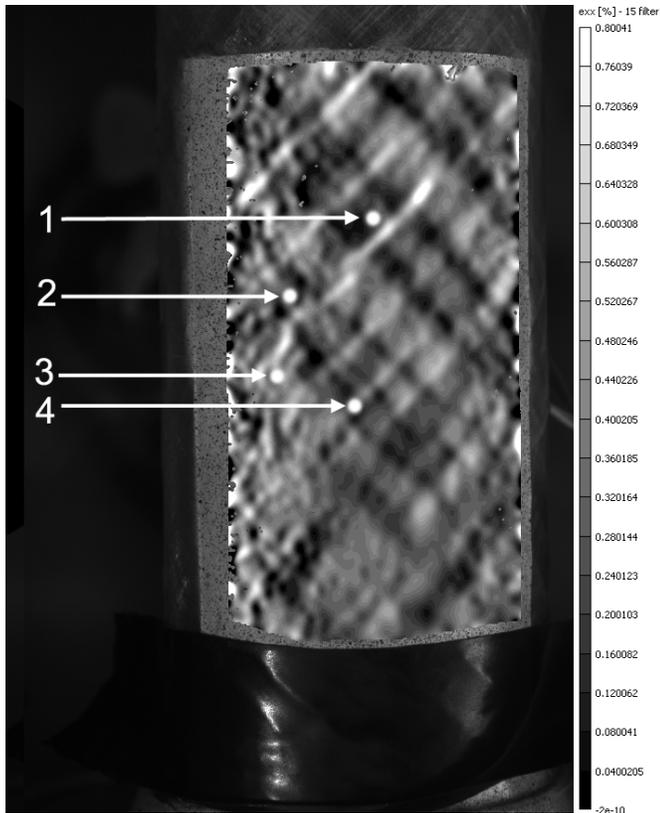
Figure 4: Map of hoop strain ('exx') for specimen B001.

From hoop and axial strain maps shown in Figs.4 and 5 respectively, it can be observed that hoop strains had lower maxima (shown by the gray-scale bars) and were also lower on average (overall darker hoop strain map) than axial strains. This behavior was noticed for all specimens, i.e. average axial strain was approximately 20-30% higher than hoop strain. This can clearly be observed from load-strain plots like the one presented in Fig.10, which shows hoop and axial strains for specimen B002. This figure also indicates that strain gage data and DIC measurements were generally in good agreement.

Some degree of pattern regularity can be observed in the strain maps shown in Figs.4-8, in which zones of high and low strains are generally aligned with the 45° winding pattern. But this must be seen as a generalization since considerable strain variations still exist along the fiber direction. Also, zones of high and low strains do not consistently match up with the winding band patterns; it appears that with respect to winding band positions these zones were shifted for each specimen differently (see e.g. Figs.7 and 8).

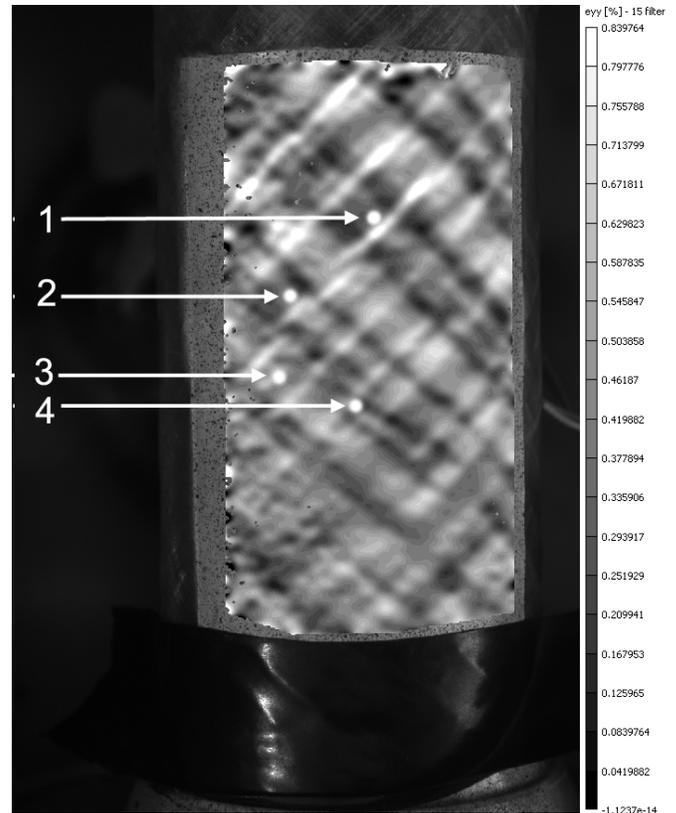
Figure 5: Map of axial strain ('eyy') for specimen B001.

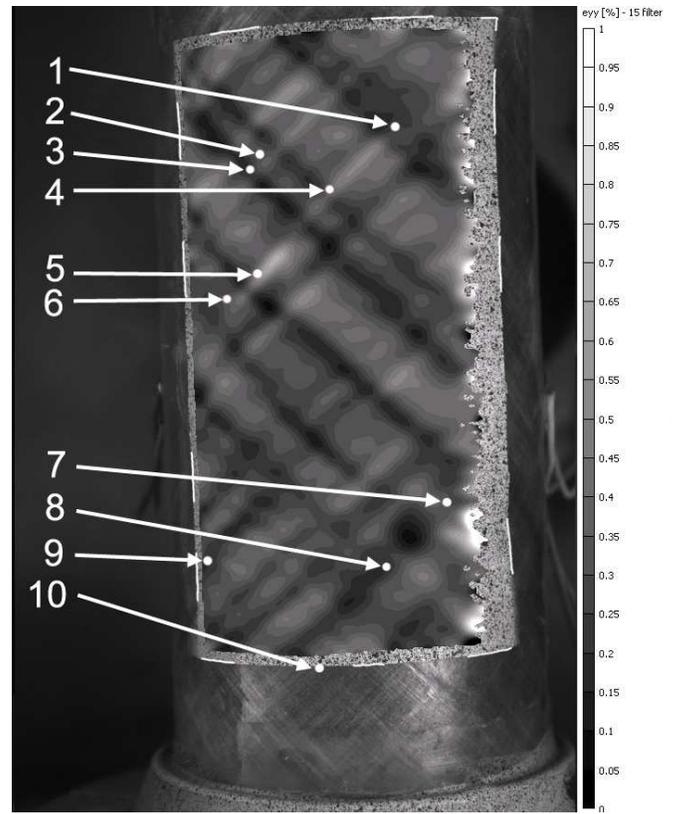
Figure 6: Map of axial strain ('eyy') for specimen B002.

For all specimens made with the broad winding band, leakage initiation sites appeared in the form of dots. The number of dots within the area of interest varied from 4 to 10. No apparent correlation between strain intensities and locations of leakage initiation points could be ascertained. For example, leakage points #1 and #3 on specimen B002 were in zones of low strains while point #5 was in an area of a high strain (see Fig.6). Similar observation can be made for the other specimens.

In terms of leakage initiation sites, one may argue that specimen B002 exhibits three specific lines that include the majority of leakage points (see Fig.6). The first of these lines is defined by points #2 and #3; the second line by points #1, #4, #5 and #6; and the last line by the points #7, #8 and #10. Hence, the assumption could be made that these lines are

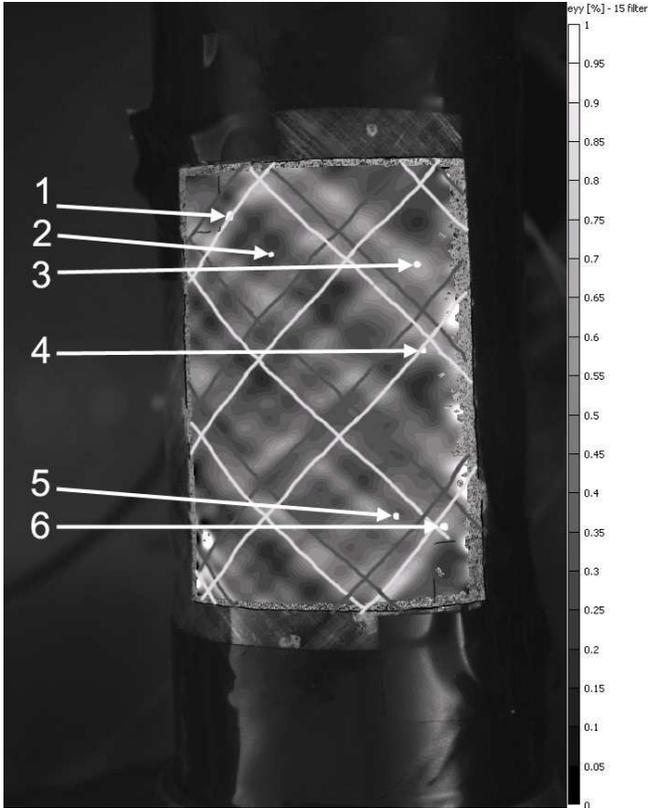
Figure 7: Map of axial strain ('eyy') for specimen B003.

sites were marked in these images by white dots or dashed lines to reveal any possible connections between strain patterns and leakage initiations sites. Another interesting detail is shown in the images for specimens B003, B004 and B006 (Figs.7-9). These specimens were wound with colored glass-fiber tracer threads that marked each side of the winding band. Hence, the winding band pattern could be reproduced and drawn onto the strain maps using white and grey lines. Note that parallel white and grey lines that are in close proximity to each other indicate a small winding band overlap that was adjusted to ensure full mandrel coverage and avoid any spots with weak or missing fiber reinforcement.

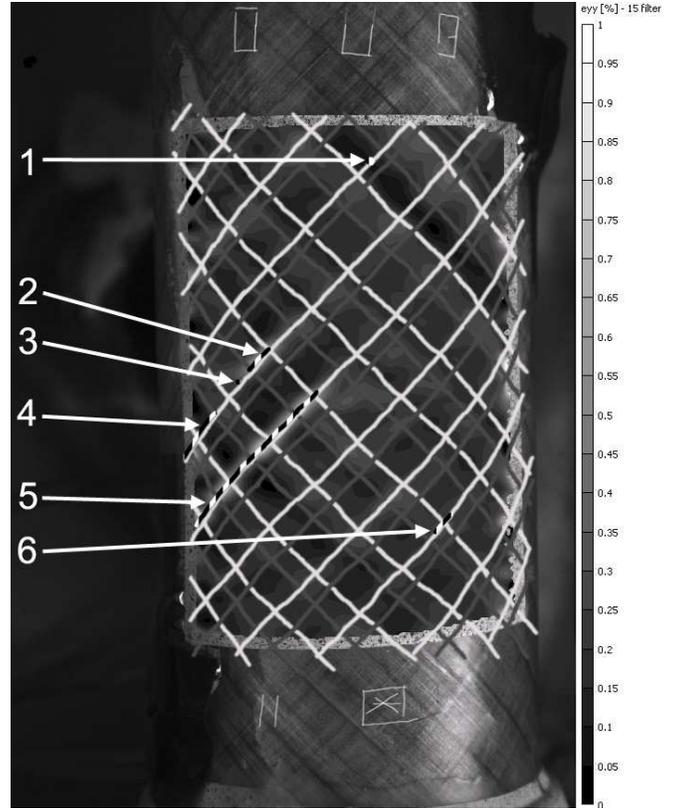
Figure 9: Map of axial strain ('eyy') for specimen B006.

As mentioned above, the winding structure for specimen B006 is more interwoven and complex since this two-layer fiber architecture was produced with a narrower winding band than the other specimens (Otherwise, the material system and testing conditions were identical for both specimen types.). This resulted in a strain map with relatively low strain variability (see Fig.9), which thus offered even less clues for a possible correlation between winding pattern and leakage behavior. At the same time a more uniform strain distribution did not produce higher leakage strength, i.e. leakage failure for specimen B006 occurred at an internal pressurization of 2.5 MPa compared to 3.5 to 4.0 MPa for the other specimens. Leakage initiation sites also appeared in the form of lines rather than points (Figure 11 provides a close-up view of such a leakage line). Leakage lines were generally visible even with the naked eye. Note that zones of elevated strain accompanied the leakage lines, and that leakage lines were located at the winding band boundaries. Hence, it seems that in specimen B006 a separation between winding bands rather than cracking within the bands themselves was the dominating mechanism for leakage failure. This is different from the damage mechanism for the other specimens where highly localized leakage sites were observed. A reason for differences in damage behavior may lie in the altered winding procedure; however, further research is required to fully understand this phenomenon.

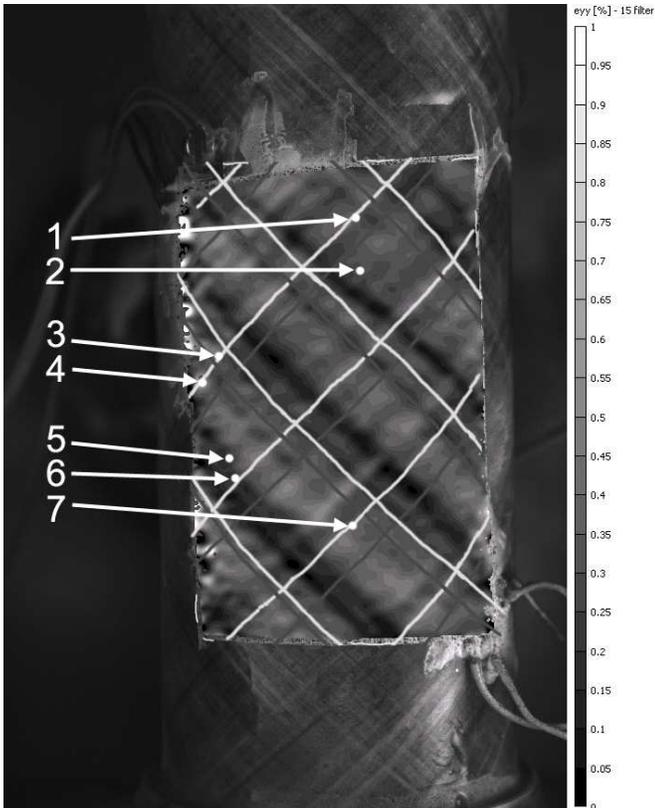
Figure 8: Map of axial strain ('eyy') for specimen B004.

related to the location of winding bands. But, close investigation of strain maps containing sketches of the winding band pattern, e.g. for specimen B003 shown in Fig.8, refutes this assumption. Here leakage points appear in seemingly random positions in zones with strains of varying magnitude.

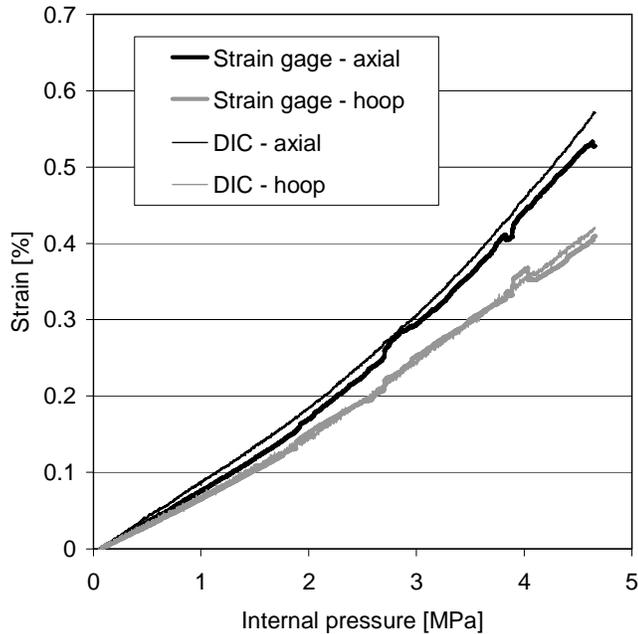
**Figure 10: Strain data from strain gages and area-averaged DIC measurements for specimen B002.**

Present experiments showed that DIC is a reliable contactless method for measuring surface strains on composite specimens. Area averaged strains from DIC analyses that were produced for the five different FRP specimens agreed well with strain gage readings.

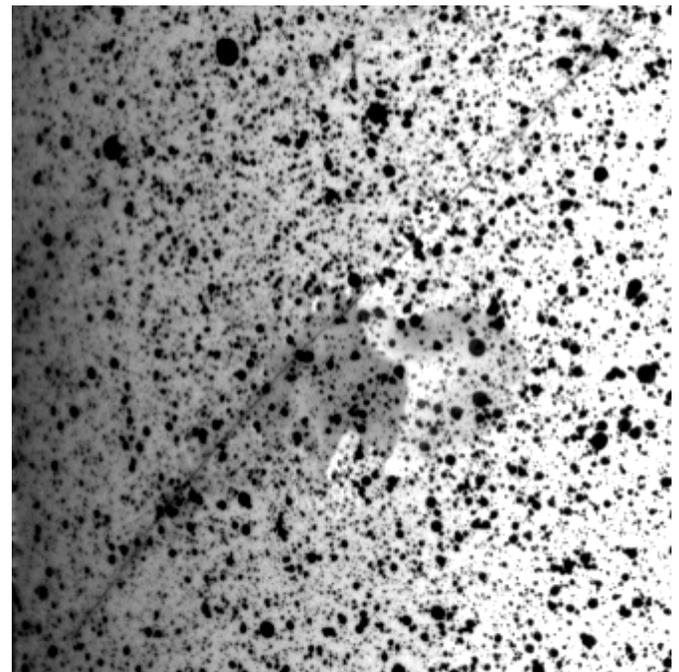
**Figure 11: Close-up view of leakage line #5 on specimen B006.**
