Damage Assessment in FRP Through Digital Imaging and Computed Tomography

Abstract

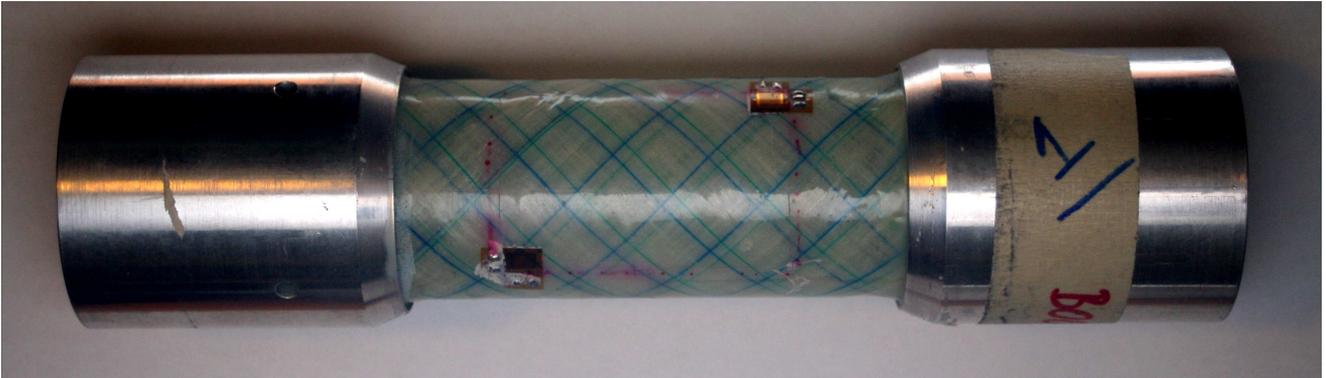
Figure 1: Tubular specimen (Spec.-ID: B004).

A reconstructed (three-dimensional) volumetric model of a specimen surface topography is shown in Figure 10 (for specimen B004). In this model the resin surface cover, which gives a specimen its glassy, smooth surface (see Figure 1), was rendered invisible based on the poor X-ray attenuation of the pure resin material. In addition, areas containing strain gauges were excluded because metallic components associated with the gauges produced artifacts that considerably degraded local image quality. In Figure 10 image pixels correspond to a physical dimension of $34\ \mu\text{m}$, which is considerably larger than the average filament diameter. Consequently, individual filaments were not resolved. The model therefore depicts a blended fiber-resin structure that is equivalent to aforementioned load-bearing fiber bed. The figure clearly shows that the associated model surface is noticeably uneven, and zones/bands with different wall thicknesses exist. Due to aforementioned unresolved challenges regarding image registration, an accurate correlation between leakage initiation sites, strain patterns and model surface topography was not possible. Yet, it can be observed that bands of elevated surface strain in Figure 8 (green and yellow hues) match the orientation of the valleys and ridges visible of the volumetric model in Figure 10. Hence, one may conjecture that elevated surface strains are caused by thickness variations in the composite fiber bed and possibly associated micro-damage features (matrix cracking).

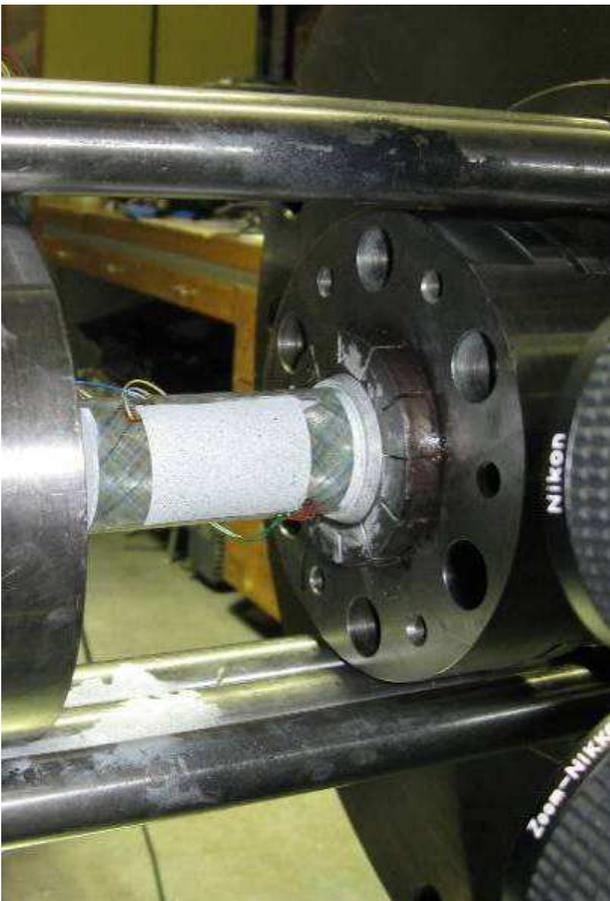
Figure 2: Specimen in testing apparatus.

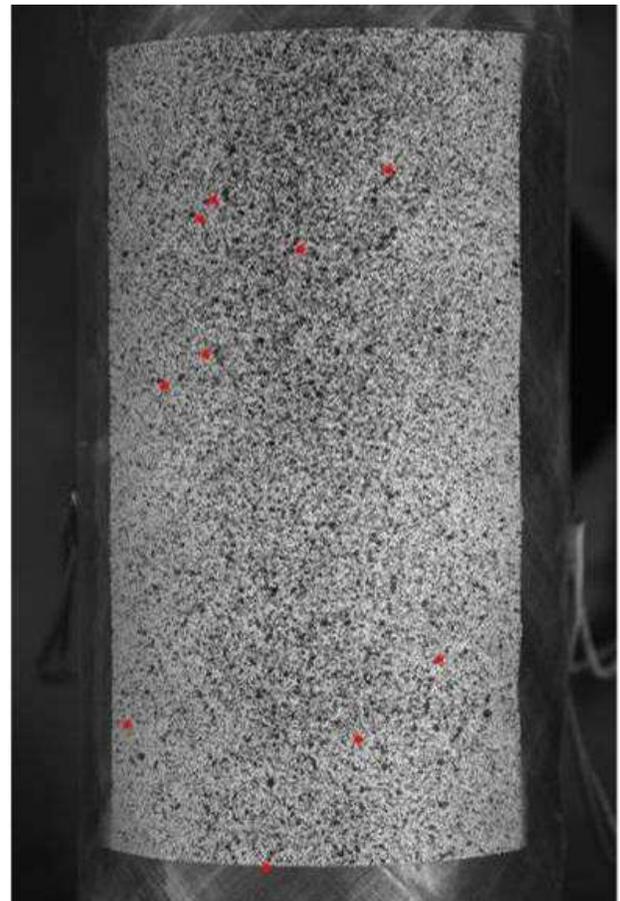
Figure 3: Markings (red dots) indicating leakage sites on specimen surface (Spec.-ID: B002).

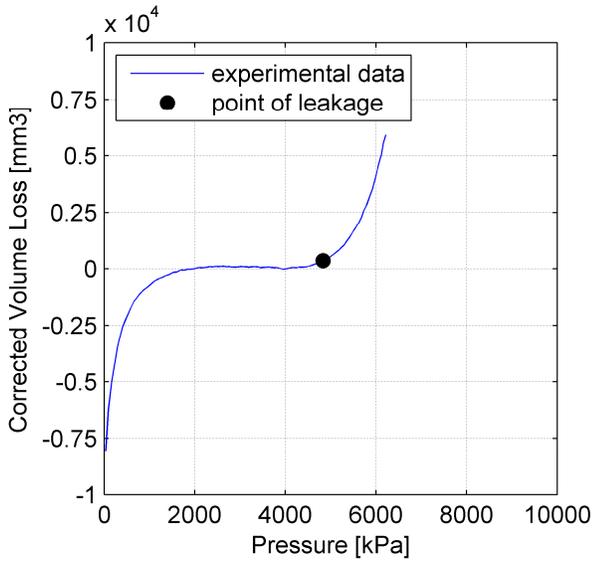
Figure 4: Specimen leakage curve (Spec.-ID: B002).

Finally, a steep rise in the curve signifies the occurrence of specimen leakage. The leakage failure point shown in Figure 4 corresponds to an arbitrarily set fluid loss, i.e. 200 mm³ (0.012 in³). Leakage failure thus defined occurred for this particular specimen at an internal pressurization of 4.8 MPa (700 psi). It shall be mentioned that fluid droplets were usually observed to emerge at pressures considerably lower than the values obtained from the leakage analysis. For the current specimen, the first sign of fluid leakage was found at 3.8 MPa (550 psi) through careful visual inspection of the images contained in the test database. The DIC procedure for optical strain measurement was aborted at 4.7 MPa (680 psi). It is noteworthy that the leakage behavior observed with present thin-walled specimens was in its appearance indistinguishable from leakage seen on specimens with greater wall thickness and same diameter; that is, the occurrence of small droplets on the specimen surface is considered a typical 'weepage' damage mode.

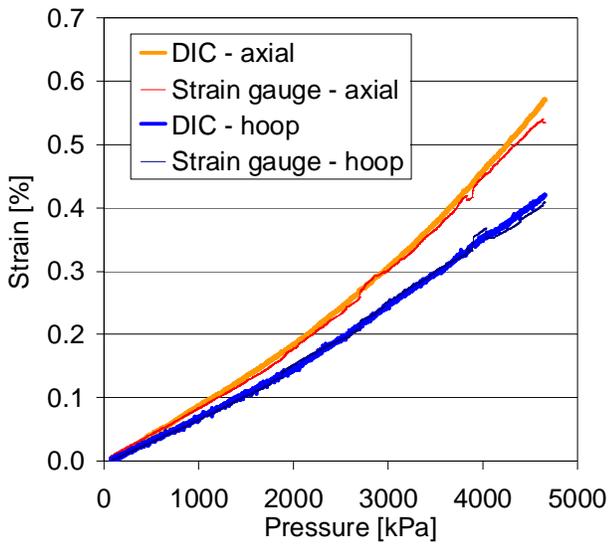
Figure 5: Strain data from gauges and image analysis (Spec.-ID: B002).

Strain data obtained from gauges corresponded well with surface averaged values computed by the DIC method. This can be observed in Figure 5 where example strain data for specimen B002 is depicted. Hence, present experiments confirmed that DIC is a reliable contactless method for measuring strains on composite specimens. Notably, measured strains were nonlinear, with circumferential strains being about 30% higher with respect to hoop strains. All specimens tested in this study exhibited this behavior. Albeit not important for the present investigation, this behavior is somewhat remarkable. Based on the specimens' [$\pm 45^\circ$] fiber architecture and the applied equi-biaxial stress loading condition, an equally equi-biaxial material response was expected, resulting in equal strains in hoop and axial directions. The observed behavior cannot be explained conclusively at this point, yet it may be speculated that the tubular structure of the samples is responsible for the deviation from truly orthotropic characteristics (for example, residual stresses may have been present in the structure, which are more likely to build-up in the hoop direction during manufacturing).

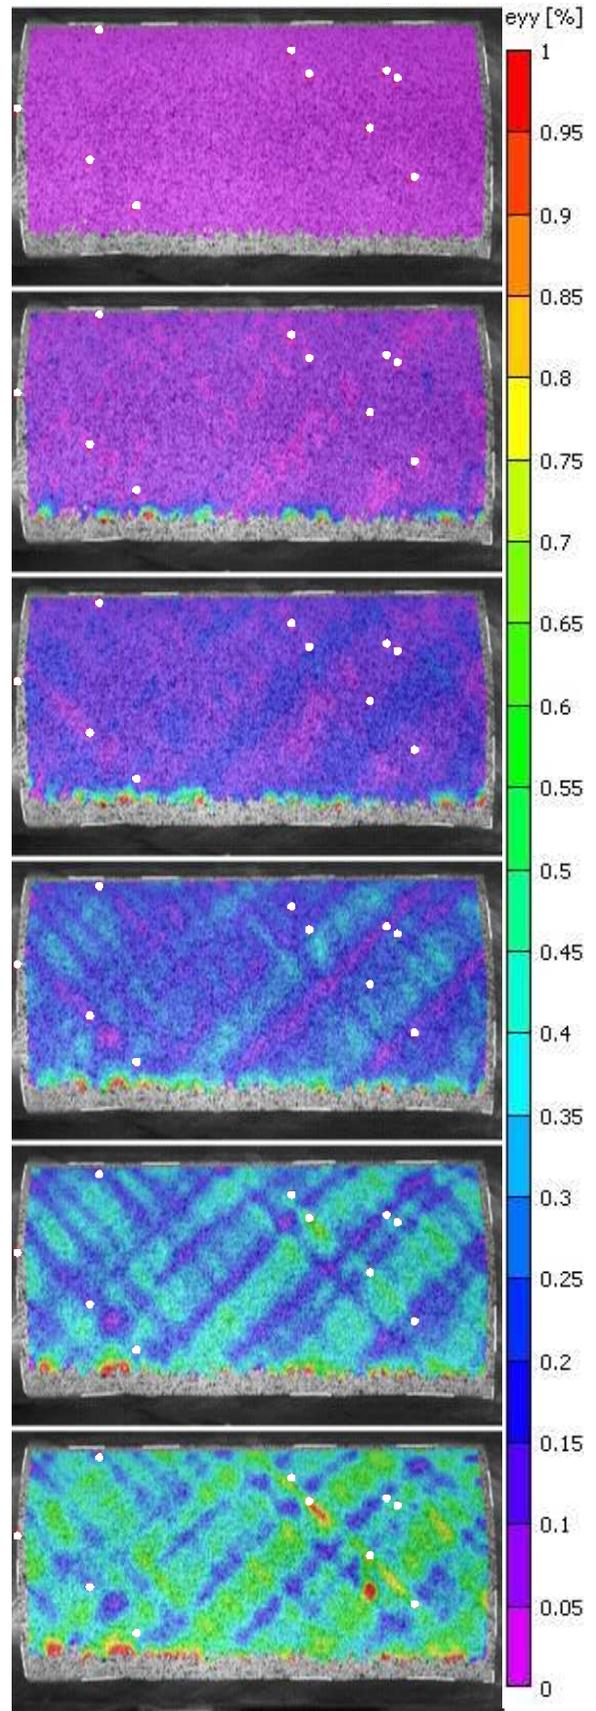
Figure 6: Axial strain maps with superimposed leakage sites (white dots) (Spec.-ID: B002).

sites. Shown in Figure 6 is the evolution of axial surface strains with increasing applied loading. Note that maps for hoop strain were not included here since they are quantitative very similar to the depicted axial strain data. In Figure 6 leakage initiation sites are depicted as white dots. The top and bottom strain maps in this figure correspond to zero loading and loading just prior to the emergence of leakage respectively. It can be observed that strains exhibited, to some extent, a periodic pattern, i.e. with increased loading, zones/bands of high and low strains evolved that were aligned with the $\pm 45^\circ$ fiber orientation. Inspection of Figure 6 shows that no conclusive correlation exists between sites of observed leakage initiation and zones of high or low strain. Moreover, leakage spots did not form any consistent pattern matching the bands of high or low strain.

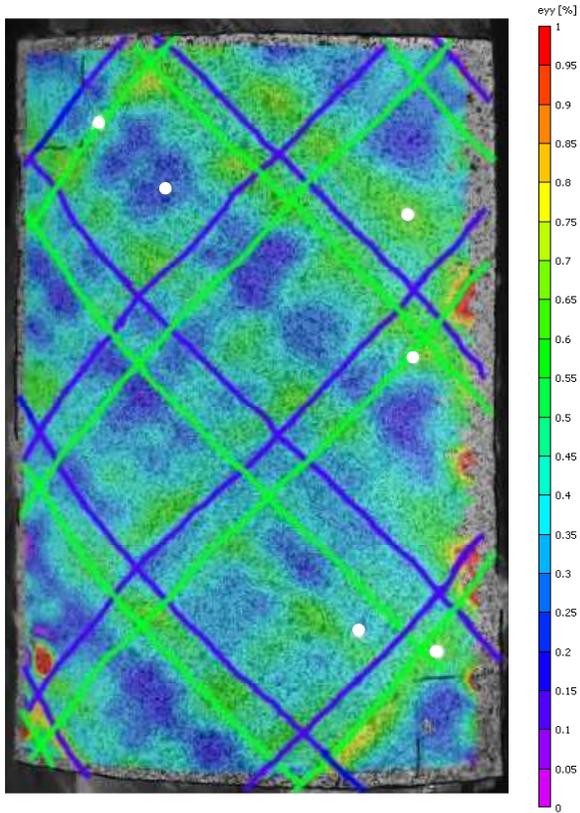
Figure 7: Axial strain maps with superimposed winding band pattern (blue and green lines) and leakage sites (white dots) (Spec.-ID: B003).

Since some specimens were manufactured with aforementioned tracer threads that marked individual winding bands, strain inhomogeneities could also be analyzed taking the winding band locations into consideration. In Figure 7 an axial strain map is presented onto which the winding band pattern was superimposed (for specimen B003). Parallel blue and green lines that are in close proximity to each other indicate a slight winding band overlap that was adjusted to achieve a uniform distribution of fiber reinforcement without gaps between winding bands. Figure 7 shows that despite a general alignment between the strain pattern and the winding band tracers, no distinct correspondence between zones of elevated strains and winding band location is apparent. It is interesting to note that locations of observed leakage initiation frequently coincide with the tracer threads, i.e. the sides/edges of winding bands. This deduction is supported by imaging from other specimens, for example, specimen B004 shown in Figure 8. Hence, it was conjectured that leakage has a higher probability to occur at winding band edges. However, no general conclusion can be drawn here based on the limited amount of data.

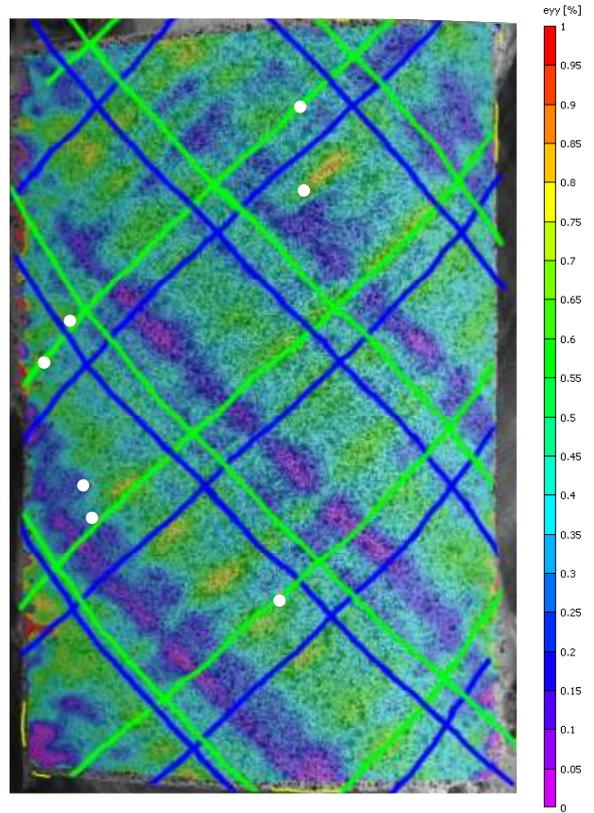
Figure 8: Axial strain maps with superimposed winding band pattern (blue and green lines) and leakage sites (white dots) (Spec.-ID: B004).

In contrast to the investigation reported in [10] the current study did not attempt to resolve individual micro-damage features such as matrix cracking through computed microtomography. (Even though the scanning equipment would have been capable to provide the required resolution.) Achieving the resolution required for such undertaking would generate excessively large datasets for the relatively large regions of interest considered in this study. Rather, the goal of current analyses was to map areal features such as wall thickness irregularities. Figure 9 shows the X-ray shadow projection for specimen B004. Note that Figure 8 (optical image) and Figure 9 (X-ray image) correspond to each other with respect to the north-south orientation; however, Figure 9 does not fully match the area of interest shown in Figure 8 since a slightly different circumferential image ori-

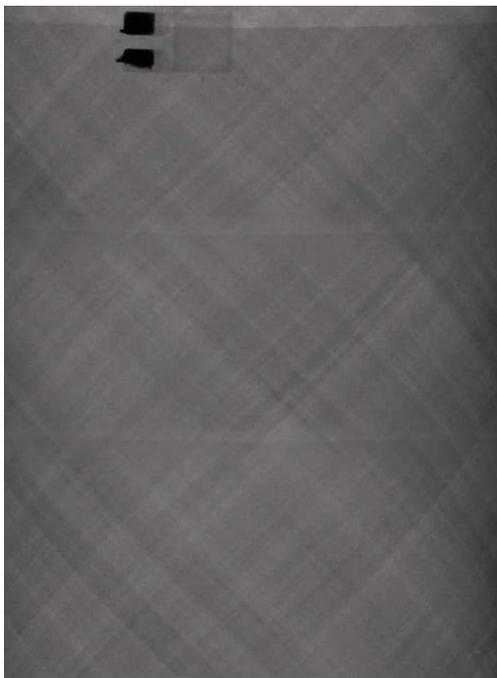
Figure 9: μ -CT shadow projection of specimen B004.

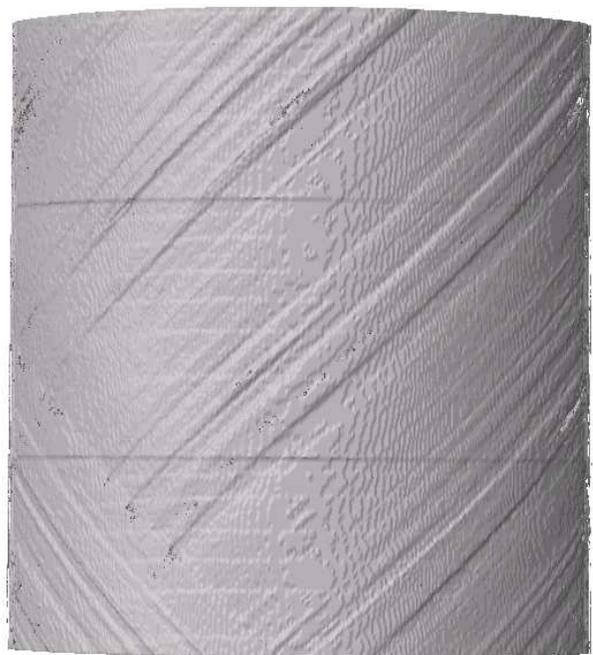
Figure 10: Three-dimensional volumetric model of specimen surface topography excluding resin surface cover (Spec.-ID: B004).

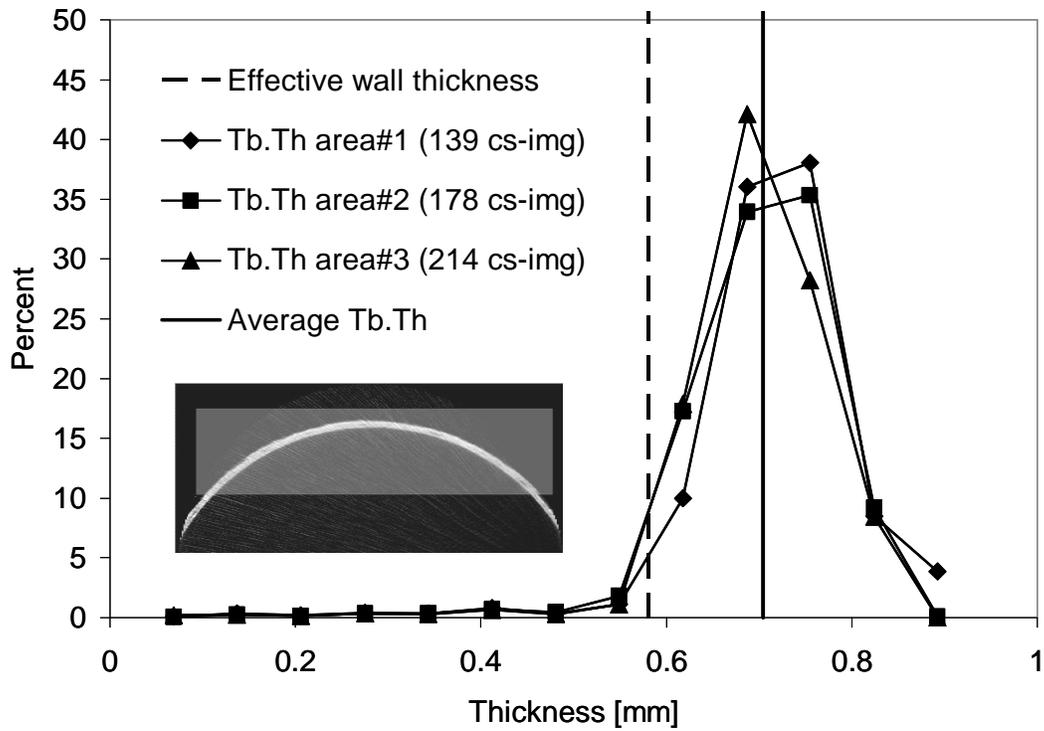
Figure 11: Effective wall and distributions and average value of trabecular thickness (Tb.Th) for specimen B004. Number of cross-section images from image set #1 to #3 is indicated as n cs-img. Insert showing measurement region (grey box) in sample cross-section image.

For the three sets of cross-section images taken from specimen B004 the wall thickness was approximated using the trabecular thickness (Tb.Th) method in conjunction with a sphere model. Herein the transition zone between image sets was neglected to avoid including artificial thickness data from the image subset reconstruction and merging process. Figure 11 shows a graph comparing the effective wall thickness (0.58 mm) and wall thickness data determined through μ -CT. From these data it becomes evident that the effective wall thickness is less than the average wall thickness estimated from the Tb.Th method (0.70 mm). It was inferred that this deviation is caused by distributed void space within the sample and resin-rich fiber composite on the sample surface, given that they influence measurements from the Tb.Th method but are neglected in the case of the effective wall thickness.
